Fix for stuck tilt lock lever

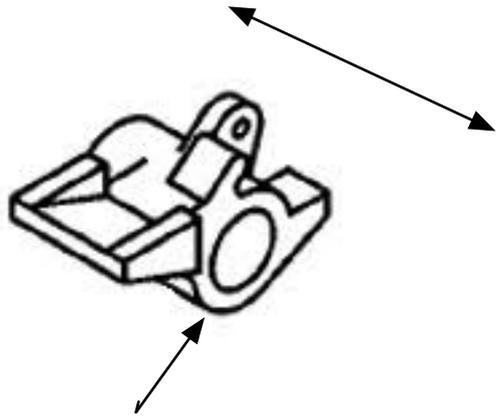
cut along axis of tilt tube

cut in this region

I used a dremmel with cutoff wheel

It did not come out pretty or very straight but it worked

A utility knife might do a better job

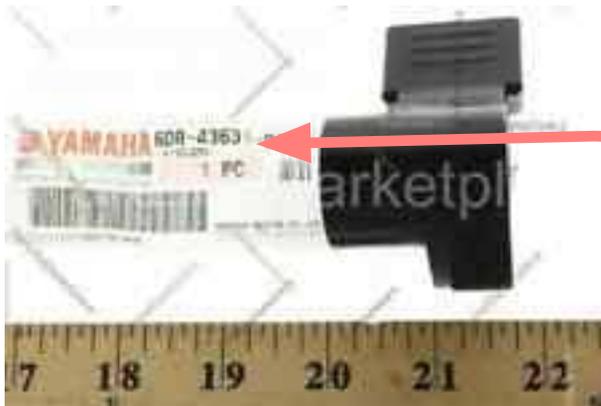
cut here along axis of tilt tube
